Automated Downgrade Truck Speed Advisory System

March 1999

Ed Miska
Engineering Branch

Ministry of Transportation and
Highways

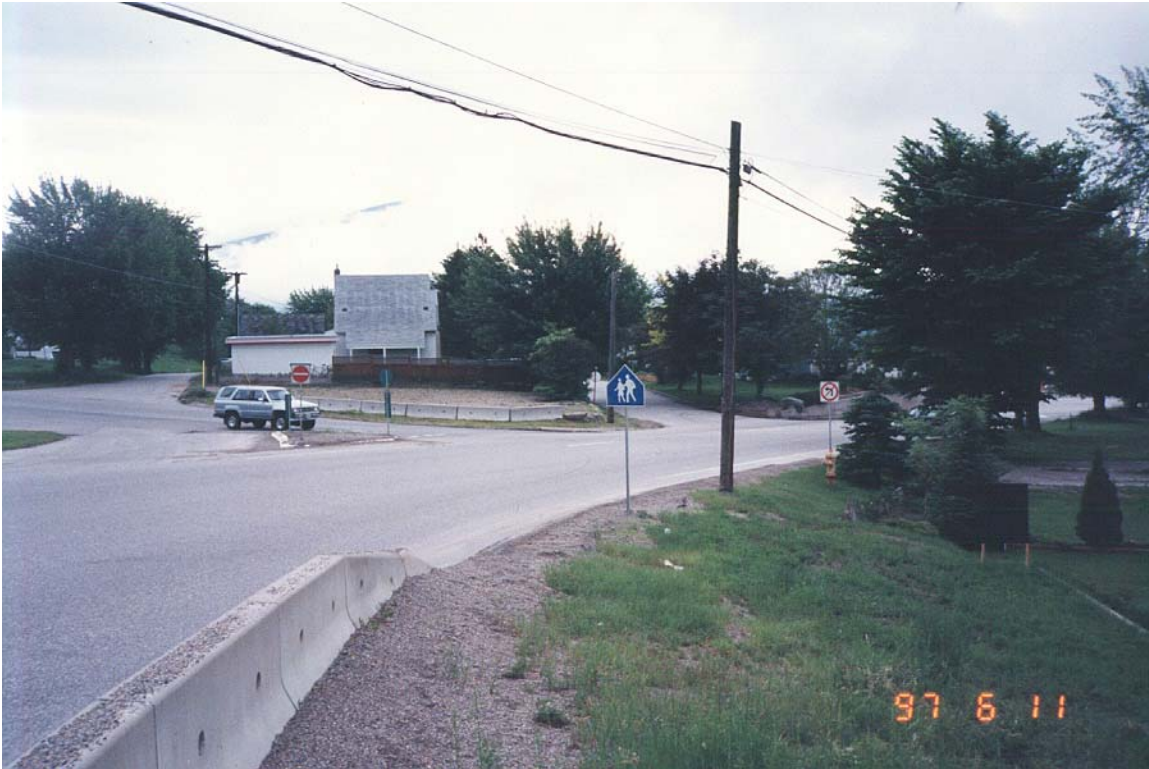
Figure 2-1 Site of Warfield Hill Truck Runaway Accident

The site accident history indicates that on average there have been 1.33 runaway related incidents per year (based on eight years of accident data). Additionally, the potential for a catastrophic incident is very high since the downgrade passes through the community of Warfield, where significant urban development exists adjacent or in very close proximity to the downgrade. In fact, the location is known for a very serious accident where a runaway truck demolished a house. Fortunately for the occupants of the house, they were not home at the time. This particular accident emphasized the potential damage a runaway accident could cause on this hill. Figure 2-1 shows the site of the accident. In the figure, note that the empty lot behind the barrier used to contain the aforementioned house.

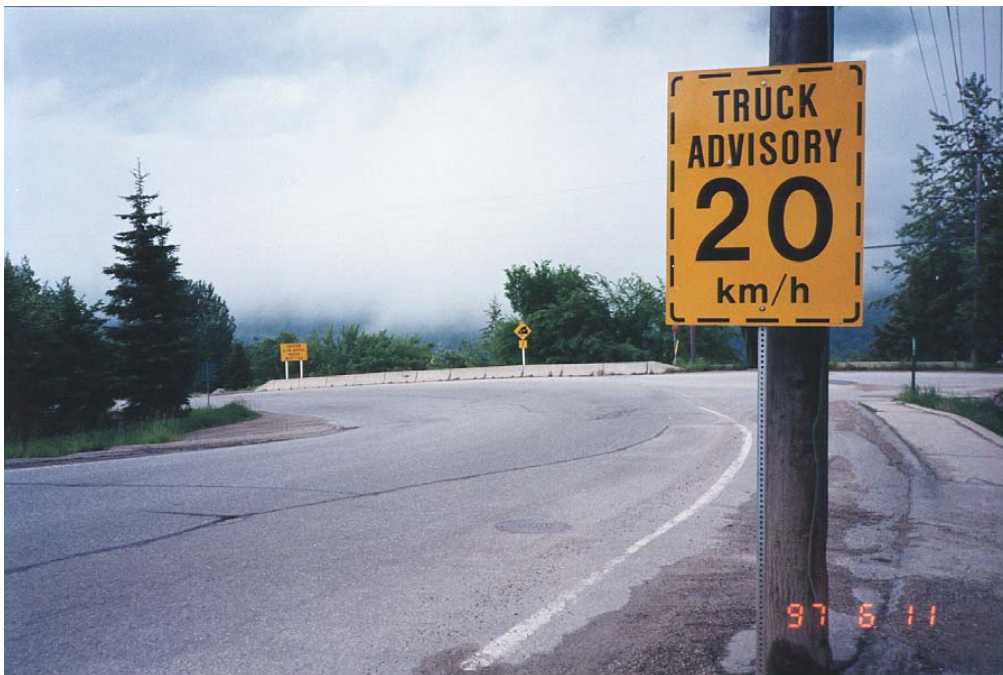
Figure 2-2 Start of the Warfield Hill

The remaining option was to locate the system after downtown Rossland. Figure 2-2 shows the driver's view after exiting downtown Rossland after a 90 degree right turn. The figure shows the truck advisory signing as well as the fact that the downgrade starts immediately.

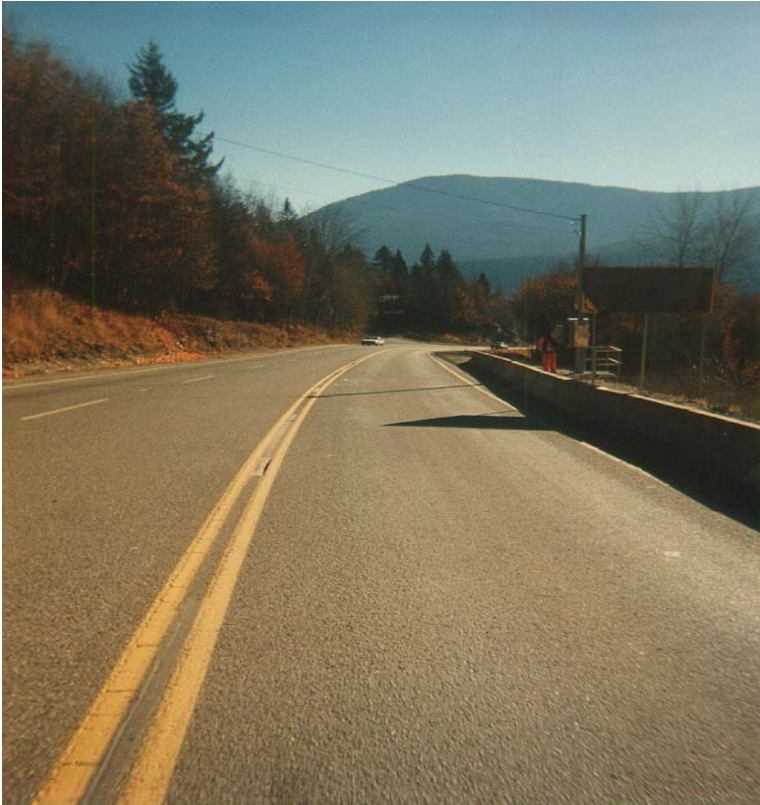
Figure 2-3 Road Segment with Sensors (located adjacent to the pole)

After much investigation by MoTH and IRD staff, it was agreed that the best location was on a short tangent section approximately 400 m after the start of the downgrade. The chosen location was the only section near the beginning of the downgrade where field observations showed that trucks maintained a constant speed. Other sections had more closely spaced curves for which it was observed that most trucks applied their brakes to some degree and hence there was a likelihood of not maintaining a constant speed over the sensors. Figure 2-3 shows the location of the sensors that are in the roadway adjacent to the pole. Note that from this position the driver cannot see the variable message sign. To alert the driver to active advisory information, there is an advisory sign “TRUCK ADVISORY SYSTEM AHEAD” (shown covered in the figure). It was decided that since the system and its active advisory messages were unique, it was necessary to alert the driver to expect this information.

The grade at the site was approximately 8%. In their proposal, IRD indicated that this would result in some loss of accuracy for the WIM system, but that this would be compensated for by installing an additional piezo-electric sensor and by adjustments in the software and calibration of the system. While the grade was greater than what would normally be used for a WIM system, IRD felt that since the grade was constant then grade compensation was possible.

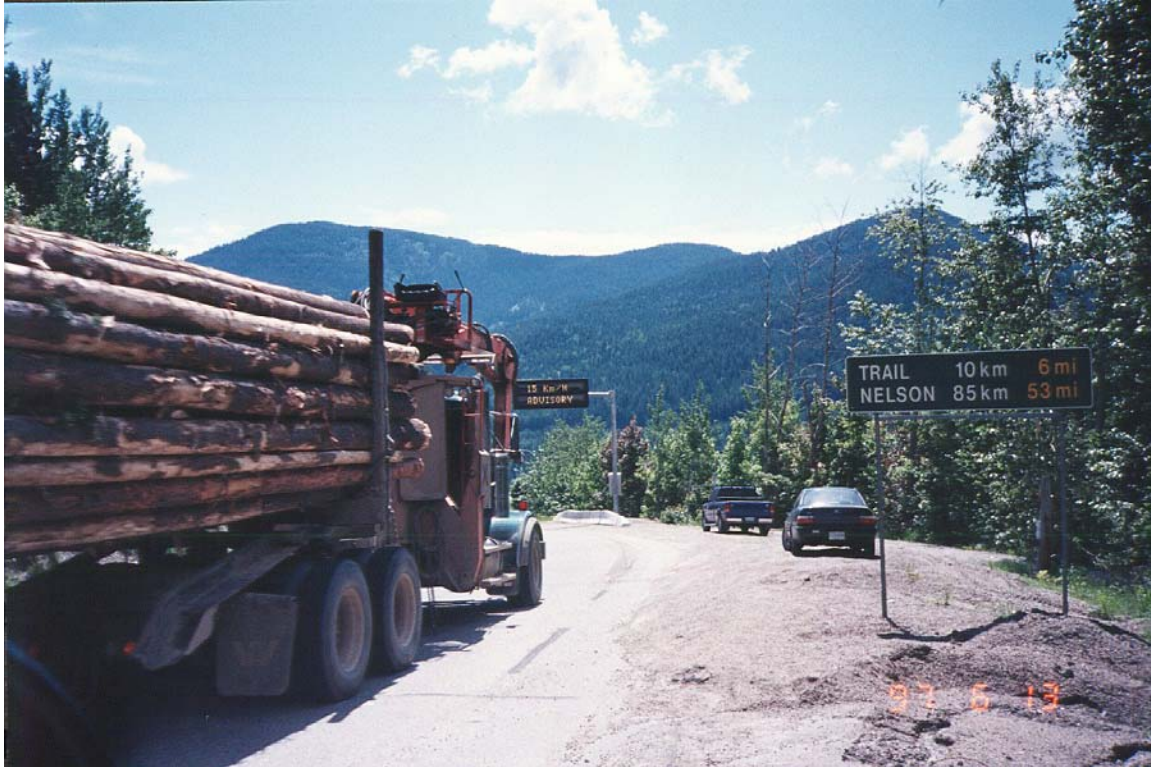
Figure 2-4 Message Sign Displaying Truck Advisory Speed

The location of the VMS sign must be sufficiently downstream of the WIM computer and sensors so that the WIM computer has enough time to process the data and send the appropriate advisory speed selection back to the VMS. The sign is shown in Figure 2-4.

Once the truck had passed over the sensors, the driver had to negotiate a turn to the right. There was insufficient distance between the sensors and the curve to place the VMS sign, hence the sign had to be after the curve. The sign is blank until the truck passes over the display loops at which point the specific advisory message for that truck is shown to the driver. Leaving the VMS blank until the truck triggers the on-loops has the effect of emphasizing that the message is specific to that particular truck. The message remains displayed on the VMS until the off-loops are triggered. The display operation is shown in Figure 2-4.

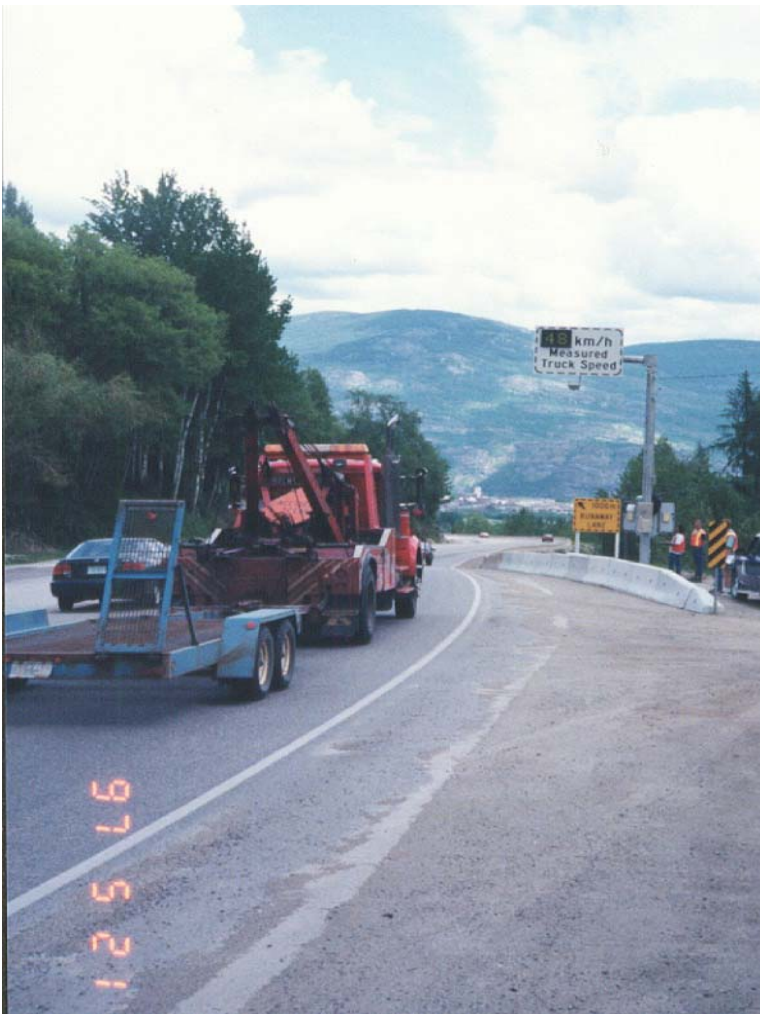
Figure 2-5 SNS Displaying Measured Truck Speed

The sign requirements for the SNS were simpler. It was decided that the system would only be required to display the measured speed. Hence, a fixed message sign would be used with two flip disk modules to display the speed digits. The sign message would read “XX Measured Truck Speed” as shown in Figure 2-5. The location of the speed notification sign is based on the same computer processing time requirements as for the DTSAS. For the SNS there was a further constraint that the sign be uphill from the truck runaway lane advisory signing. The SNS sign was placed 200 m uphill from the first truck runaway lane distance sign. The static signboard was manufactured by the Provincial Sign Shop. Telespot provided the flip disk modules to MoTH who arranged for their installation into the signboard.
